USK BRIDGE PLANNING REPORT

Prepared For:
Pend Oreille County Public Works Department

April 2021

Nicholls Kovich
Engineering, PLLC

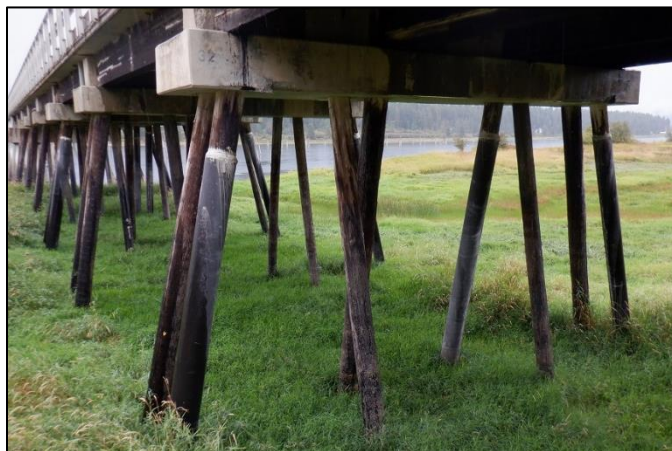
Photo 2 - Timber pile jacketing (Bent 32)

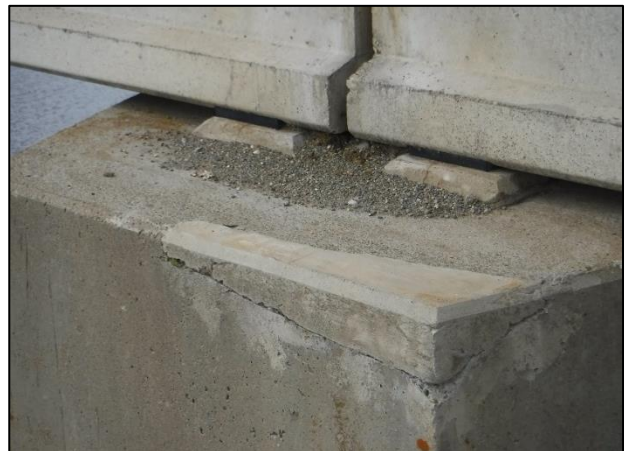
Photo 3 - Pier cap spalling repair

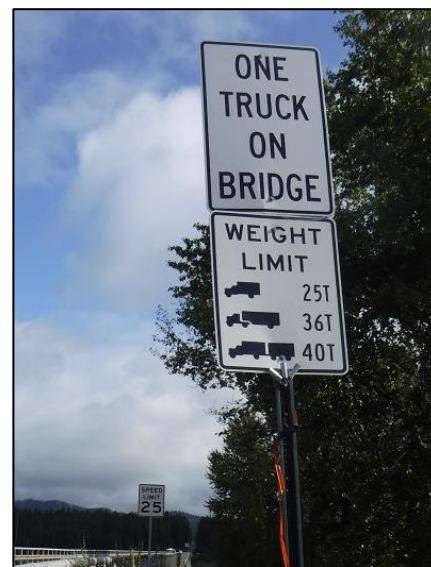
The bridge is currently posted for “One Truck on Bridge” as well as weight restrictions for (3) AASHTO trucks (Photo 4). Per the 2016 load rating, if there is one truck at a time within each span, the bridge does not need to be posted for legal loads, but Overload 2 should be restricted. The coding for WSBIS Item 1293 (Open/Closed/Posted) is “R” which indicates the bridge is posted for other load-capacity restrictions such as number of vehicles on the bridge. The weight limit sign posted reflects loads right at the legal limit.

Photo 4 - Current load posting

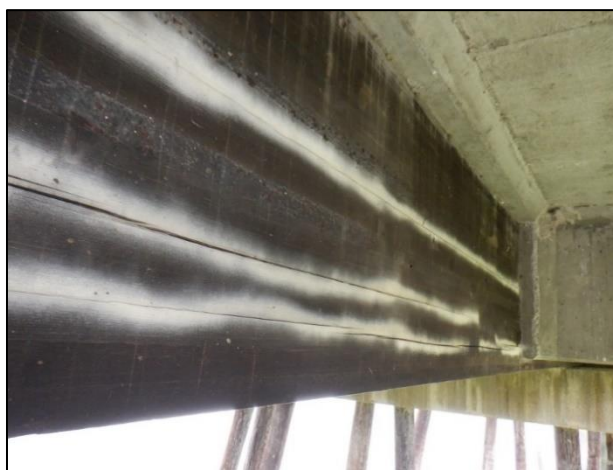
Photo 5 – Checking in glulam girders (highlighted in white)

The existing glulam girders have widespread checking on their sides (Photo 5) and 60% of the glulam girders have side checking up to 3/8-inch wide.

Checking in glulam girders is a natural process that occurs due to separation of the wood fibers. The outer surface of the girder loses moisture to the atmosphere and begins to shrink while the interior of the girder loses moisture at a much slower rate. This differential shrinkage results in checking. Checking can be differentiated from delamination (inadequate glue between laminations) by observing whether or not the separation is smooth or torn along the grain. Because the separation of the wood fiber is not smooth (Photo 6), delamination is not deemed to be the main cause.

Checking is typically not a major structural concern, unless it affects a significant portion of the girder. Per the APA-Engineered Wood Association, checking becomes a structural concern when at least a third of the girder width is separated as well as one-third of the girder length. Because this is the case on the Usk Bridge, the load rating has taken appropriate reductions in allowable shear stresses (using 4.5-inches as the deepest check).

Since the glulam girders were originally treated with preservatives at installation and then re-treated during 2010, they appear to be well protected from the potential for decay. If the checking does not change significantly over the next 10 years, the lifespan of these glulam girders could be considered to be at least another 20 to 25 years.

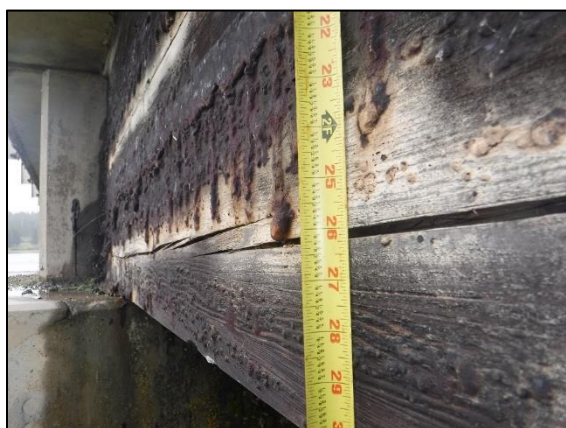
Photo 6 – Closeup of checking in glulam girders

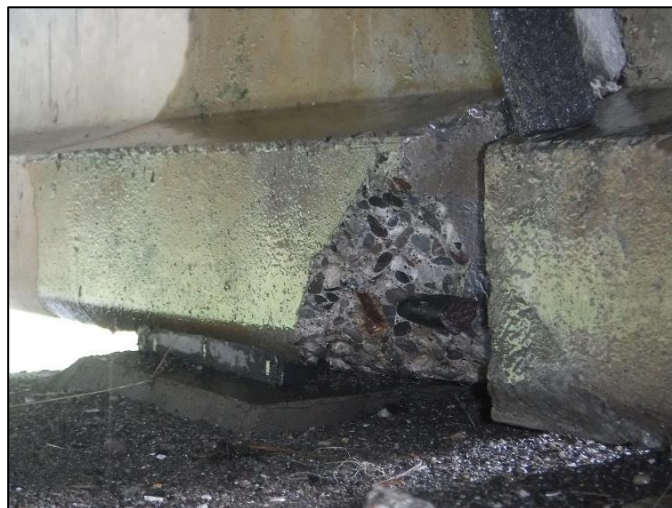
Photo 7 – Typical spalling at end of girder

Two of the main defects in the girders include hairline web cracking and spalling at the bearing seats (Photo 7). There are at least eight girders with longitudinal cracking that follows the same path as the harped strands (Photo 8). And 30% of all girders have spalls at the bearing seats with an additional 10% that are cracked that could lead to spalling.

- **Continue to monitor girder web cracking for any changes.**
- **Monitor spalls for extension into bearing area.**
- **Keep girder bearing seats dry - See Section 7.1: Expansion Joint Replacement**

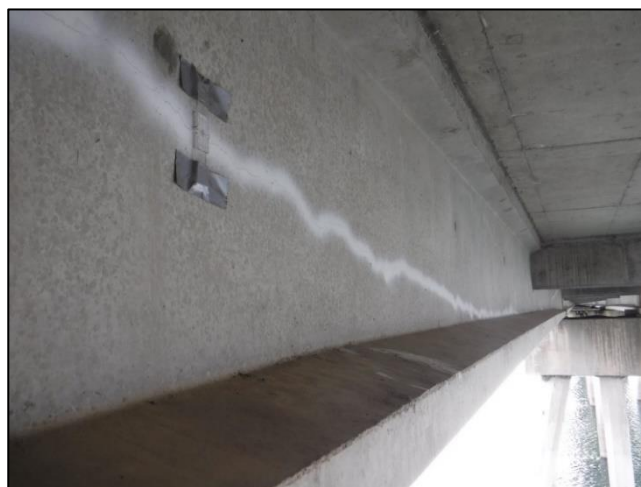
In 2014, crack gauges were installed to monitor any changes in web cracking. Pend Oreille County indicated that when the monitors were installed, the cracking had been present for a long time. Since 2014, the crack gauges have shown zero to little change. During the 2019 bridge inspection, many of the cracked areas were sounded for delaminations and none were found.

Photo 8 - Hairline cracking in girder web along path of harped strands.

While the geometrics and reinforcing in the girders may not meet current design standards, the cracks are not significant enough to affect the load-carrying capacity of the girders. It is recommended that the web cracking continue to be monitored for any changes. Significant changes would include an increase in crack size from hairline ($< 1/16$ ") to narrow size ($1/16$ " to $1/8$ ").

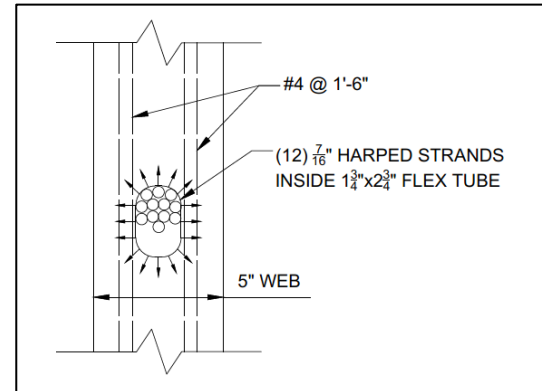
Figure 2: Post-tensioning detail - existing girder web

The post-tensioning duct is shown to be $1\frac{3}{4}$ " x $2\frac{3}{4}$ " flextube in the original contract drawings, see Figure 2. Because the duct is grouted after the strands are post-tensioned, the grout imparts an outward radial pressure on the tube. Past studies have indicated that grouting can cause significant stresses in the web, particularly those post-tensioning tubes that are oval in shape as the ones in the Usk Bridge.

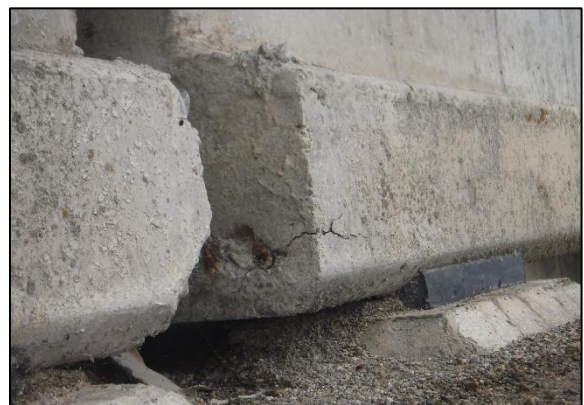
As previously mentioned, cracking and spalling at the base of the girders near the bearing seats is presently affecting about 40% of the concrete girders. Cracking at the ends of girders within the pre-tensioned zone is not uncommon due to the amount of compressive force that is applied due to prestressing (Photo 9). Additionally, since prestressing was in its early stages of development when these girders were fabricated, there is insufficient reinforcing steel in the bottom of the girders to resist the cracking. Girders fabricated today include more confinement reinforcing to avoid this problem.

Photo 9 - Crack propagating at end of girder

Once cracking initiates, it can lead to spalling which is actively occurring in the Usk girders. It is particularly important to keep these areas as dry as possible to prevent additional deterioration. These defects should be monitored over time. They could become a concern if spalling extends into the area above the bearing pad or if the prestressing strand begins to show significant damage due to corrosion.

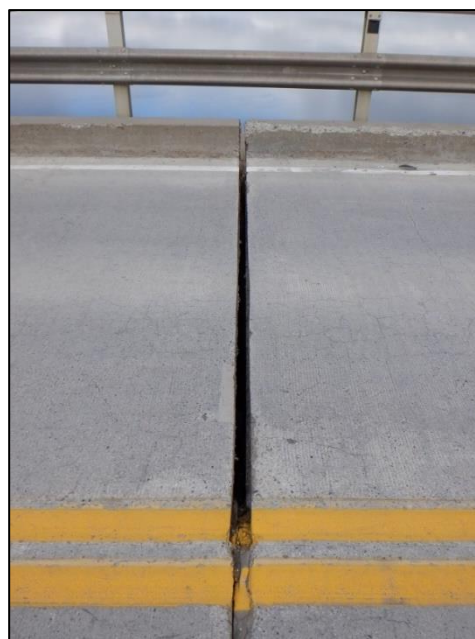
The Usk Bridge was originally constructed with a 2.5-inch wide poured rubber joint. In 2010, all expansion joints were replaced with Rapid Cure Silicone (RCS) Sealant (Dow 932S per the project special provisions). Within two years of repair, the joints were noted to need maintenance and within 6 years of repair, many joints were noted to be “open”.

Photo 10 - Joint Failure showing open gap between girders

Presently, within the concrete girder spans, there are (5) joints that have completely failed and are totally open and (13) additional joints that are more than 50% open (Photo 10). Also a significant number of joints have debonded. Damaged joints are allowing water and debris to penetrate the deck and saturate the pier cap and bearing seats (Photo 11). The moisture is accelerating deterioration of the pier caps and girder ends and the debris build-up is allowing the moisture to be retained.

- **Top Priority: Repair expansion joints – See Section 7.1: Expansion Joint Replacement**

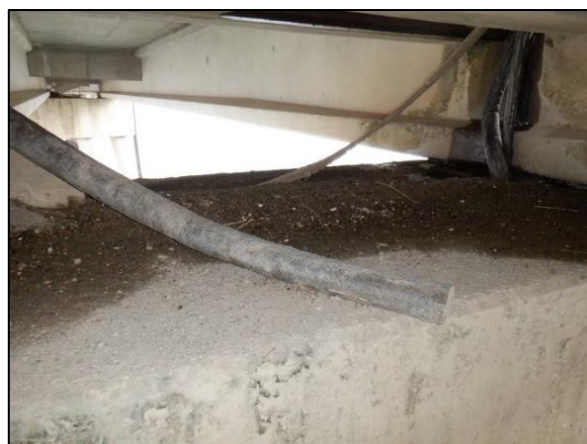
Photo 11 – Joint failure and debris buildup on pier cap

In order to facilitate pier cap repair and to reduce retention of moisture, it is highly recommended that debris buildup be removed from the concrete pier caps. Based on literature review and current state of practice, washing of decks, bearings, joints and substructure seats can elongate the usable life of those elements and delay the need for bridge replacement. Eliminating the debris removes a storage medium for water, roadway debris, and potential road salts which will deteriorate bridge elements.

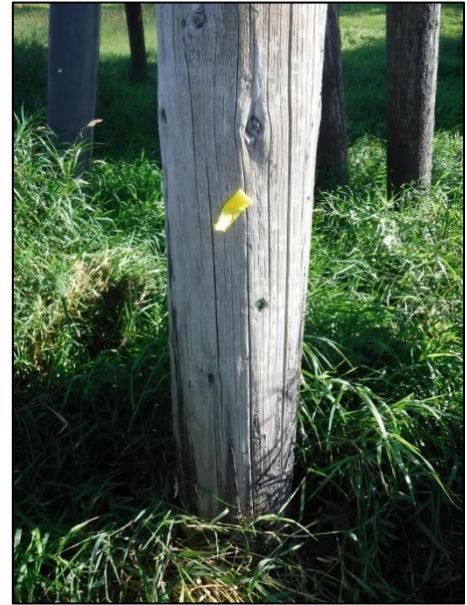
The timber piles have various deficiencies including wide checking, wear, abrasion, and some piles sound punky, indicating potential decay. Two piles were bored (using 3/8" bit) during the previous inspection and no measurable rot was found.

Presently there are (34) piles in Condition State 3 which indicates structural defects, but they do not significantly affect structural capacity. At the next inspection cycle, it would be desirable to perform non-destructive testing, such as with resistance drilling, for a more detailed analysis which would provide valuable insight regarding the pile's internal defects. This data could then be used to determine which of the (34) piles are in most need of repair to increase their lifespan. From soundings, visual inspections, and borings, there are approximately (8) to (12) timber piles in need of repair.

Photo 12: Yellow-tagged timber pile

- **Wrap/jacket timber piling in most severe conditions – See Section 7.2: Timber Piling Repair**

Potential repairs for pile checking depend on severity and can range from preservative treatment to steel banding to crack filling and then pile jacketing for the most severe cases. Fiber-reinforced polymer (FRP) pile jackets are suitable for repairing piling that needs an increase in strength, but do not require total replacement. The space between the pile and the jacket is filled with a marine epoxy which completely fills cracks and voids. The FRP pile jacket system protects the pile from the elements and it cuts out oxygen access to the wood, thereby eliminating the potential for decay. Cost estimating in this planning report assumes twelve piles would be repaired with pile jacketing.

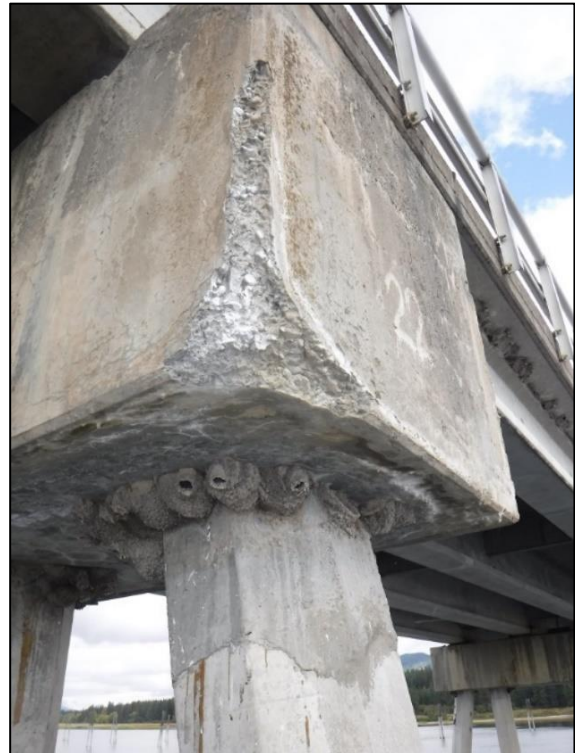
There are (43) concrete pier caps that support both the timber glulam and concrete girders. The majority of the pier caps have exfoliation, spalling, cracking, and/or delaminations at the ends, corners, or bottoms of the caps (Photo 13).

“From these specimens, the distress in the concrete is related to two major factors: cyclic freezing on non-air entrained concrete, and alkali-silica reactions between a siltstone component of the aggregates and the cement paste.”

Alkali-silica reaction (ASR) occurs due to a chemical reaction between silica aggregate and alkali hydroxides in the cement paste. The product of the reaction is alkali-silica gel that has a tendency to absorb water and swell, causing cracking and surface pop-outs. Often the first symptom of alkali-silica distress is map cracking spread across the face of the concrete. ASR concrete that is routinely exposed to moisture has a much higher chance of continued expansion. While ASR cannot be eliminated, the rate of expansion can sometimes be reduced using various mitigation measures.

Photo 13 - Exfoliation at corner of pier cap

The recommended mitigation measures at this time for the Usk Bridge are No. 1 (Improved Drainage) and No. 4 (Crack filling/Patching). The rate of expansion can sometimes be reduced by taking steps to maintain the concrete in a condition that is as dry as possible. This can be accomplished by repairing and maintaining the expansion joints. Additionally, areas that are heavily delaminated or cracked should be a focus of spall repair efforts.

It is recommended to repair major spalling at pier caps in Condition State 3, with special focus on pier caps supported by timber piles. This scope of work would include removal of unsound concrete, protection of existing reinforcement, adding drilled anchors/reinforcement as necessary, and forming and pouring the damaged area with a high-strength repair mortar.

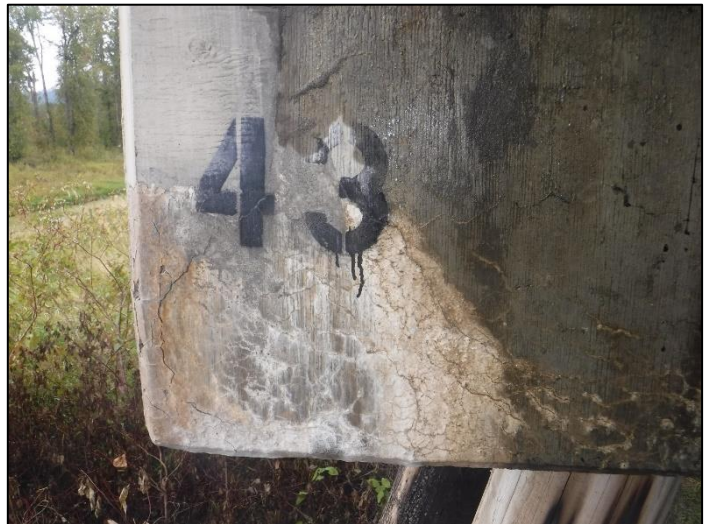
Photo 14: ASR Damage at bottom corner of pier cap.

The degree to which reinforcing bars provide containment can affect differential ASR expansion which, in turn, can affect the integrity of the structure. Concrete that is heavily reinforced with hooked bars is preferable to minimal reinforcement with non-hooked bars. In a review of the reinforcing details for the Usk Bridge, the concrete caps at the timber piles have the least confining reinforcement (no hooked reinforcement nor reinforcement near the bottom of the cap - see Figure 3). This correlates to observed deterioration in the field with delaminations and cracking near the bottom of the timber pier caps (Photo 14).

- Repair spalled areas in Condition State 3 with focus on timber pier caps.

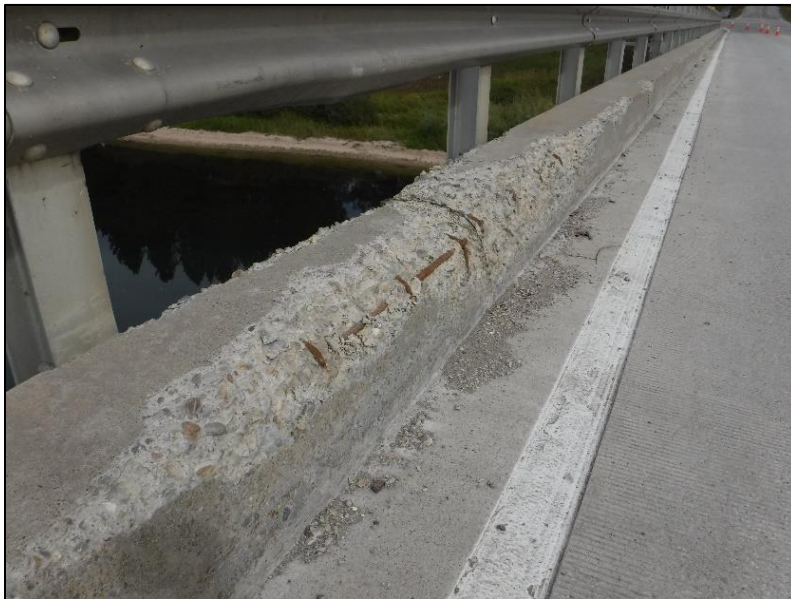
The Usk Bridge has 4,700 linear feet of 12-inch tall concrete curbs on each side of the bridge deck. There is extensive exfoliation, spalling, and exposed rebar with 25% of the total curb length in poor condition. There are (12) joint locations where the spalling is severe enough to expose multiple reinforcing bars (Photo 15). The spallings appear to be due to freeze-thaw damage. Concrete in other portions of the structure was determined to be non-air-entrained; therefore, it is reasonable to assume that the curbs may suffer from the same mix design issues. It is recommended to repair those portions of the curb with exposed reinforcing. Once the reinforcing is exposed, there is a higher chance of corrosion and further spalling deterioration. Additionally, heavy spalling and exposed bars make the curbs more susceptible to impact damage.

Photo 15 - Exfoliation of curb with exposed rebar

- **Repair curbs with exposed reinforcing – See Section 6.1**
- **Repair impact-damaged railing – See Section 6.2**

Concrete curb repair would consist of localized repairs to heavily damaged curbs and areas with exposed reinforcing bars. There are presently (12) areas that are recommended for repairs. Repair work would consist of one lane closure, removing damaged or loose concrete, and replacing with a high-early strength repair mortar to minimize traffic disruptions. The purpose of the repair would be to protect the existing reinforcement and structural integrity of the curbs.

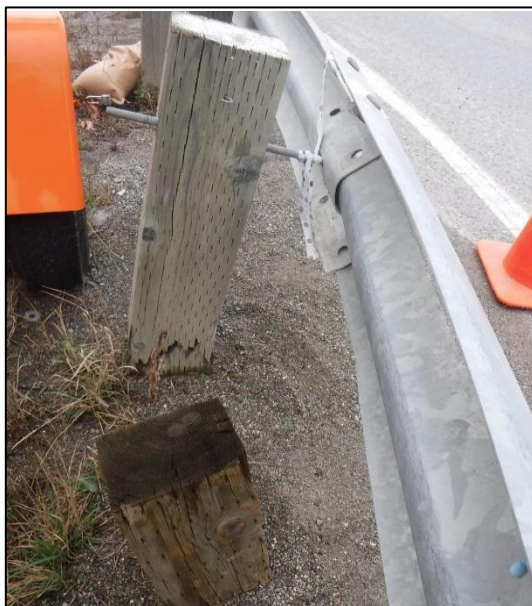
There are several areas where the bridge railing has been damaged due to impact. This occurs in the steel railposts on the bridge, as well as timber posts in the approach guardrail. It is desirable to make these repairs as well, although they are not as high as a priority.

Photo 16 – Approach guardrail damage

Bridge railing repair consists of repairing impact-damaged approach rail at the southeast bridge approach (Photo 16) and replacing impact-damaged railposts and bolts in Span 5. Due to impact, there is also an open gap in the rail top longitudinal rail (Photo 17). This repair work could be contracted out directly with a Contractor specializing in bridge and approach guardrail.

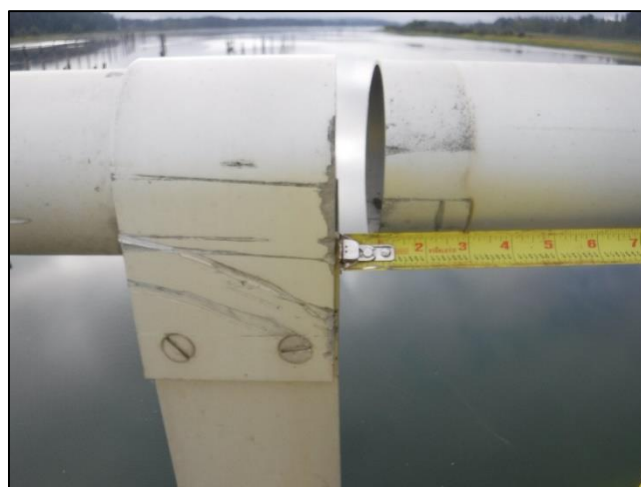
Photo 17 - Open gap at longitudinal bridge rail
